RoaDrain™ Subsurface Capillary Break Layer – Interstate Highway 494, MN

Project Name: 1-494 Lane Additions

Location: Bloomington, MN

Owner/Engineer: MnDOT

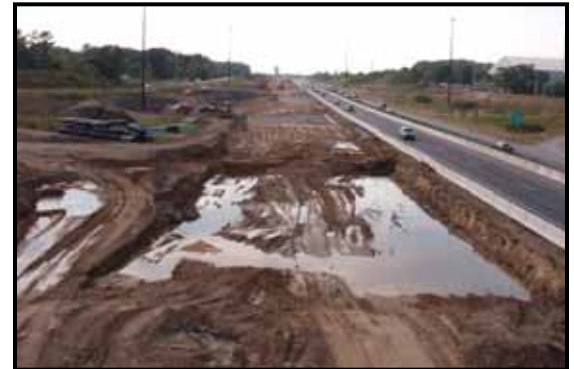
Looking West from Hwy 169 overpass during construction reveals the extraordinary high water table in this location

The elevation of I-494 dips considerably for some distance providing required clearance under Hwy 169 placing the surface of the roadway just a few feet above the surrounding water table. This area was not only prone to frequent flooding but also in need of frequent repair.

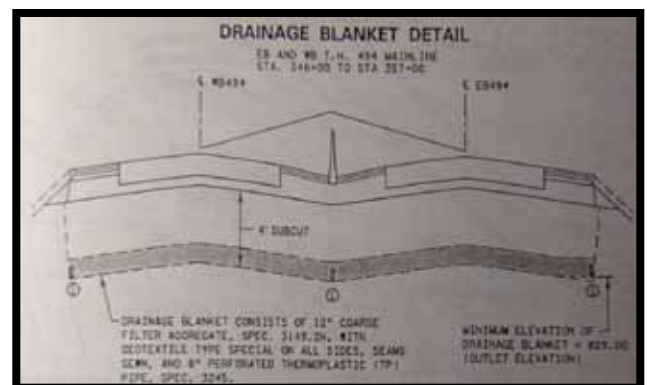
RoaDrain™ was paced at the same elevation of the intended drainage blanket. Additional borrow was used to make up for the difference in thickness.

In recognition of these conditions in this stretch of I-494, designers were careful to include a drainage blanket at the bottom of the sub excavation, prior to the placement of select granular sub-base. The drainage blanket, constructed of a 12" layer of open graded coarse filter aggregate wrapped in an 8oz nonwoven geotextile, would be connected to perforated pipes to carry away excess moisture. It would also serve to prevent the formation of ice lenses resulting from capillary rise.

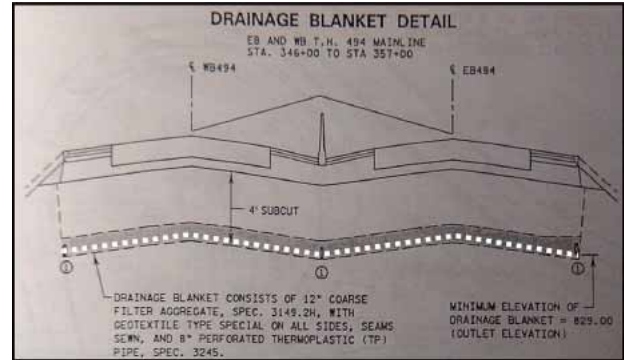
RoaDrain™ was placed at the same elevation of the intended drainage blanket. Additional borrow was used to make up for the difference in thickness.

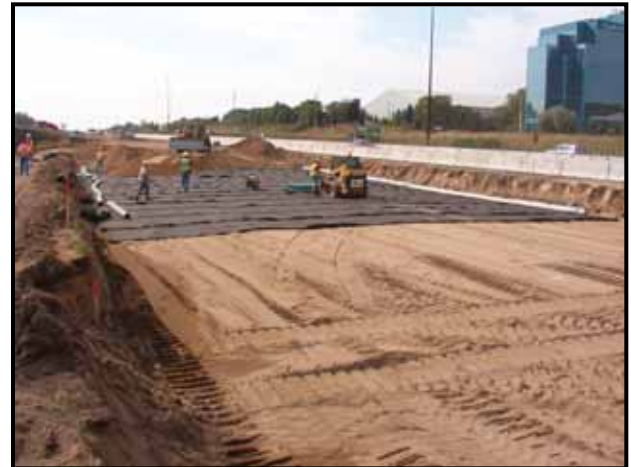
RoaDrain™ panels being deployed

It is believed the drainage blanket would have functioned as intended once constructed. The challenge however was in the construction and the cost associated with doing so. Even in an area of plentiful aggregates, the proper aggregate was difficult to source. The stage construction as well as concerns of stability of the rock all added to the challenges faced by the general contractor that were reflected in the overall cost. Through a local representative, the general contractor became aware of RoaDrain and immediately recognized the potential advantages. The solution to typical problems associated with roadway drainage is RoaDrain™. By providing “EXCELLENT” drainage, RoaDrain™ will greatly extend the service life of roads and reduce maintenance costs. RoaDrain™ is a synthetic subsurface drainage layer (SSDL) that provides a flow rate up to 5 times greater than a typical open graded base layer. Durable nonwoven geotextile filters are laminated to the top and bottom of a void maintaining, triplanar geonet core. The result is a sub-surface drainage layer that out performs natural stone in performance, longevity, ease of installation and cost. The void-maintaining triplanar core prevents the top and bottom geotextile filters from ever touching, forming an effective capillary break.
